TECHNICAL LEAFLET IVR

BIOLOGICAL CORROSION

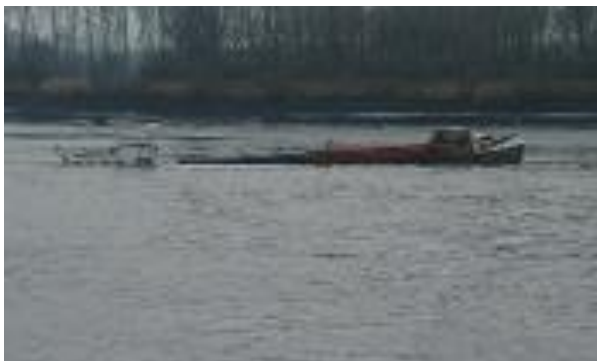
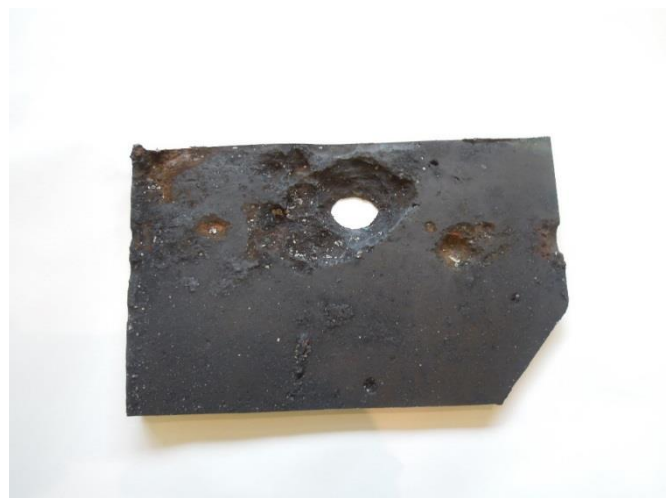
In recent years, an increasing number of cases of leaking engine rooms, caused by very local perforations of the ship's plating have been noted. This happened despite the recent class renewal in which bottom inspection and thickness measurements showed that the plating was sound. In these cases, investigation reveals that the water ingress is by very local corrosion perforations. It is an aggressive corrosion that starts at the inner side of the plating and that proceeds to the outside till a perforation occurs. Typically, these perforations are mainly crater shape with sloping sides while the plating surrounding the craters still measured its optimal, sound thickness.

While corrosion is a chemical process, in these cases, it is caused by microbiological activity. This form of corrosion is mostly found in engine rooms because these bacteria flourish in carbonaceous bilge water. It is just because they flourish in bilges that they are also difficult to detect. Bilges are hidden below the engine room floor plates and are mostly dirty.

This phenomenon is mostly seen in somewhat older ships. This kind of corruptions, starting from the inside, cannot be detected during a bottom survey from the outside. Finding one of these craters during random thickness measurements would therefore be pure coincidence. In the case of class renewals, it is also not common practice to clean the bilges thoroughly for inspection.

It is because of this hidden character that makes them so dangerous. The development of these perforations is sudden and unexpected and can lead to high consequential damage (flooded engine room, towage,...). It is advisable that on board of older ships older, the floor plates in the engine room periodically are removed (advisably once every 20 years) in order to allow the cleaning of the bilges with the pressure washer and to preserve the inside of the plates.
