## IVR damage prevention leaflet

### Watch your closed cooling water system with box-cooler

Water leakages from below the cylinder head; cracked cylinder liner collars.

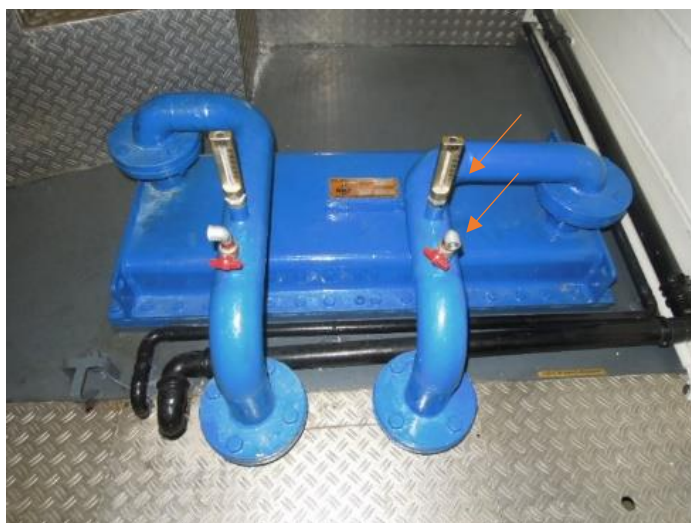
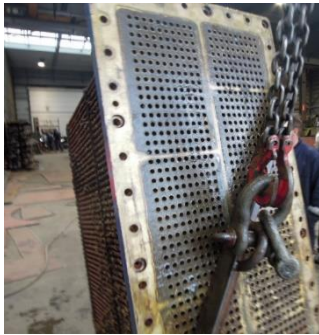
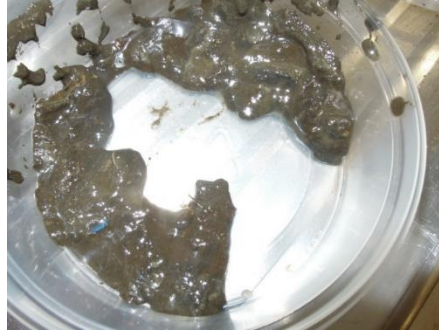
The box-cooler has been removed from the ship and an investigation on it was carried out.

The pipes of the piping bundle appeared to be soiled at the inside.

The internal pollution of the box-cooler created a too high pressure difference over the cooler. Consequently, a depression occurred at the suction side of the cooling water pump. Because of this negative suction pressure, the cooling water pump was not functioning any longer according its design curves and delivered consequently a too low rate. The too low rate created an insufficient cooling of the engine. This led to cracked cylinder liner collars and water leakages. The lower cooling water rate also changed the flow pattern of the cooling water inside the engine block (pressure, speed) which caused the existence of the cavitation phenomenon.

The damage mechanism starts with the internal pollution of the box-cooler. This pollution has been analysed in a laboratory. The analyses result reveals that the pollution is a deposit of calcium phosphate and calcium silicate. The chemical compounds arise by the presence of calcium in the cooling water and the inhibitor. Over time (years), the cooling water inhibitor thus produces chemical compounds which settle at the inside of the pipes of the box-cooler, leading to blockage of the pipes.

- install permanently pressure gauges at the inlet and outlet of the box-cooler and observe regularly the pressures (especially during sailing at full load). The pressure difference may **never** be higher than the value described by the box-cooler manufacturer. In case of too high pressure difference, the box-cooler inside needs to be thoroughly cleaned.

Ask the box-cooler manufacturer for the exact maximum allowed pressure difference.

- install permanently a pressure gauge at the cooling water pump suction. The pressure may **never** be lower (negative) than zero millibar. A depression as such is not allowed at the suction of the cooling water pump.

In case that the pressure difference over the box-cooler is within accepted values and that there is nevertheless a depression at the cooling water pump suction, contact the engine manufacturer for advice.
