IVR Technical Leaflet

LED TECHNOLOGY CAUSING ELECTROMAGNETIC INTERFERENCE

© IVR Technical Leaflet – Led Technology causing electromagnetic interference – January 2020

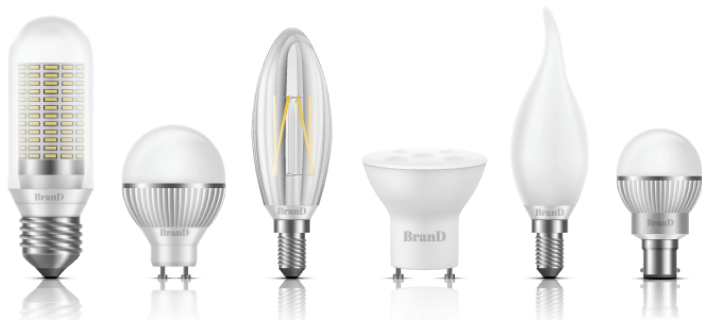
Although the lighting complies with the various relevant standards such as the EN 60945 en EN 55015 for navigation lights and searchlights, installation in the vicinity of antennas interferes with radiotelephone reception. The interference ceases when the lights are switched off.

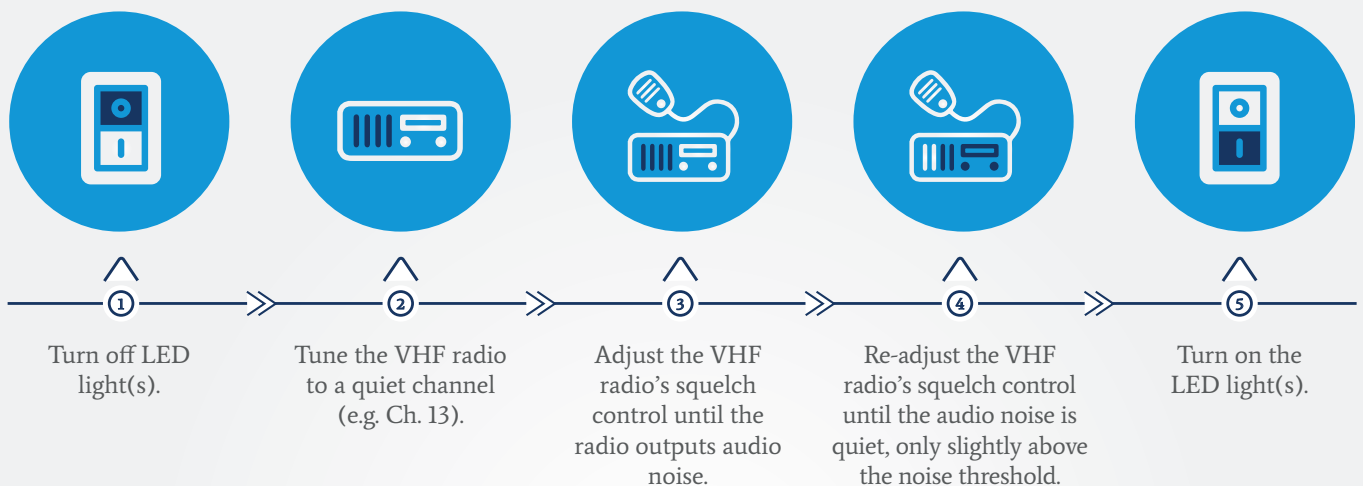
Strong radio interference from LED sources may not be immediately evident to maritime radio users. Nonetheless, it may be possible to test for the presence of LED interference by using the following procedures

If the radio now outputs audio noise, then the LED lights have raised the noise floor. (Noise floor is generally the amount of interfering signals / static received beyond the specific signal or channel being monitored.)

If the noise floor is found to have been raised, then it is likely that both shipboard VHF marine radio and AIS reception are being degraded by LED lighting.
