Caterpillar MAK M43C/M46DF Inline - Engine block cam shaft bearing support

Service Information

No. 0021M43 • Issue 1; February 13, 2023

M43C/M46DF Inline - Engine block cam shaft bearing support

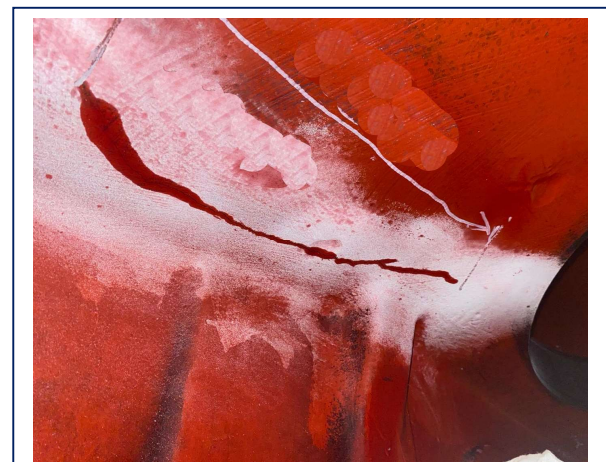
figure 1

Continuous monitoring of our engine type product health indicated a rare occurrence of cracks in the engine block below the camshaft bearing.

It was found that the presence of small irregularities in the cast skin, combined with high engine loads and frequent load changes, could possibly initiate crack propagation.

Figure 1 shows a severe crack as seen from the side of the crankcase. Figure 2 shows the same crack seen from the side of the camshaft compartment, directly below the camshaft bearing. Depending on the classification society, such a crack can be repaired by metal stitching. Longer cracks are beyond repair and a new engine block is indicated.

As a precautionary measure, we recommend checking the camshaft bearing by means of Magnaflux for small cracks in the casting skin or casting flaws. All

irregularities must be ground out and compressive stresses applied to the surface. After these measures, the engine block can be considered reliable for the life of the engine.
