STRENGTH AND LOADING ISSUES

From time to time, cases/casualties involving the **breaking and subsequent salvage of inland navigation barges** occur. The incidents mostly occur during or shortly after loading operations. The first questions that then arise are:

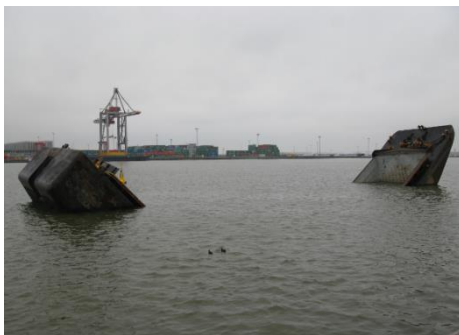
Some older barges may indeed suffer from degraded sections in their construction. At the same time, investigation has shown that this may not necessarily be the case, but that an incorrect loading and even an incorrect unloading procedure was to blame.

The construction design of an inland navigation barge cannot be compared to that of a seagoing vessel. While seagoing vessels are designed to withstand heavy weather, rough seas, waves, etc., an inland navigation barge is designed to sail in sheltered water. Moreover, historically, barges are designed to carry cargo in bulk or in bags, which should be equally spread over the entire tank top of the cargo hold.

Anyhow, for loading very heavy and concentrated cargo, it is recommended to carry out a strength calculation beforehand on basis of which it can be determined which measures have to be taken to avoid overload of the barge construction.

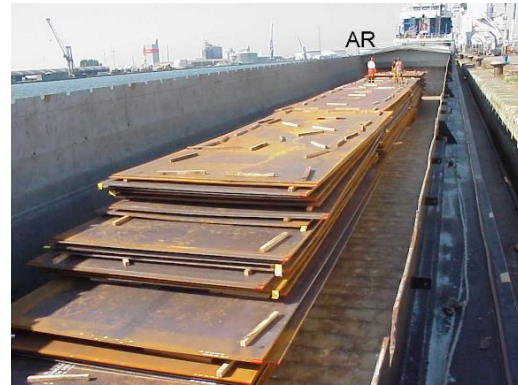
Furthermore, a proper athwart ship distribution of the cargo load should be respected. Once the cargo is loaded any other way, the bottom tends to bent in transverse direction, the effect of which is increased by the hydrostatic water pressure in the ship's sides.

The photograph about the barge loaded with heavy steel plates shows an example of such faulty loading. The heavy steel plate stacks do not cover the entire length of the cargo hold; moreover, the cargo weight is concentrated near the barge centre line, rather than having been spread sideways. Shortly after leaving its berth, this barge suddenly collapsed and sank immediately.

When concentrated heavy loads have to be loaded on board of an inland navigation barge, it is possible to take certain precautions in order to avoid the risk of breaking.

The longitudinal bending by cargo that cannot be loaded over the full length of the hold, can be compensated by adding ballast, (e.g. sand) in the forward part, respectively aft part of the hold

In order to avoid excessive transverse bending by loading narrow heavy cargo in the centreline of the barge, transversal beams or wooden battens or thick steel plates spread over the full breadth of the cargo hold can be used.
